## Pembroke Town Walls Project 28/03 to 01/04 2022

Photo record of the Pembroke Town Walls project, undertaken by Pembrokeshire College Learners from the 28th March to the 1st April 2022.

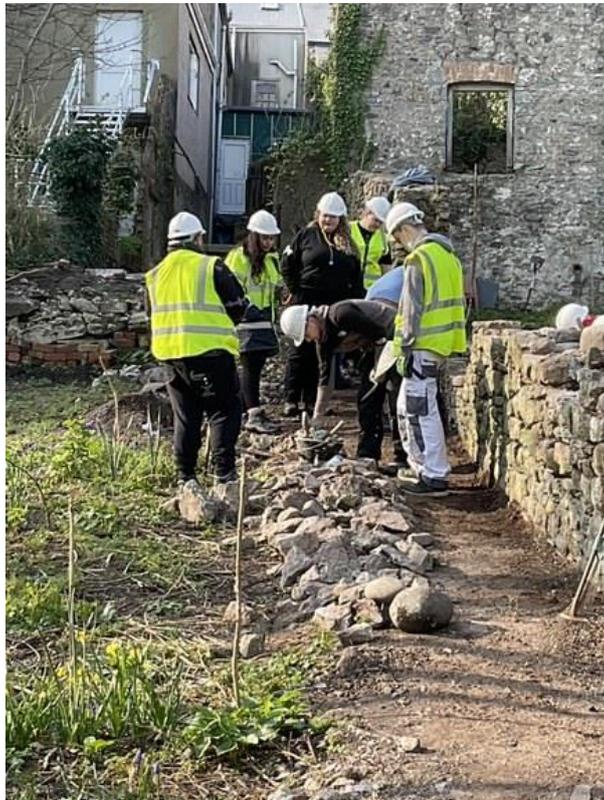
*2 - Learners removing and sorting stones*

The initial stage involved removal of existing stones and old mortar, along with earth and plant growth which had damaged and weakened the wall. Once a solid course of existing stone was reached, this was cleaned to allow for the new wall to be built upon it. The first course of stones was relaid into fresh mortar, made by the learners.

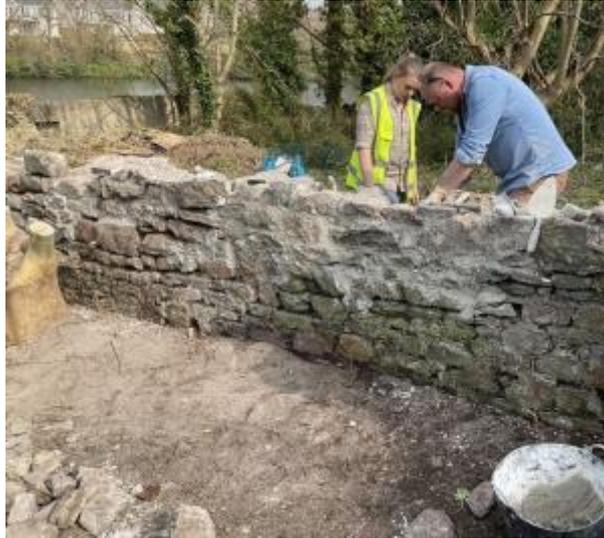
*3 - Oliver working with Iona to ensure the face of the new wall was in line with the original*

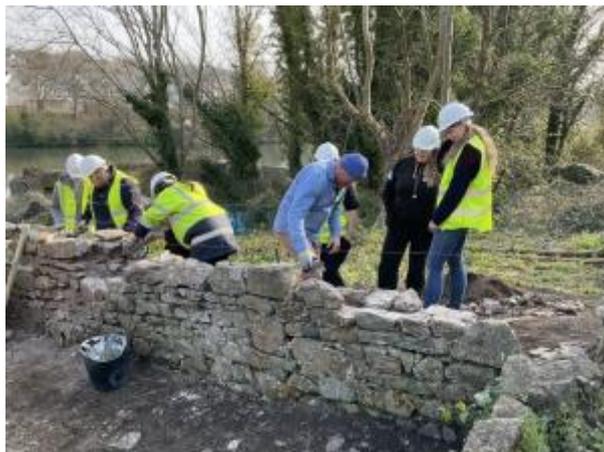
*5 - Oliver shows learners how to correctly identify how stones are replaced in the wall.*

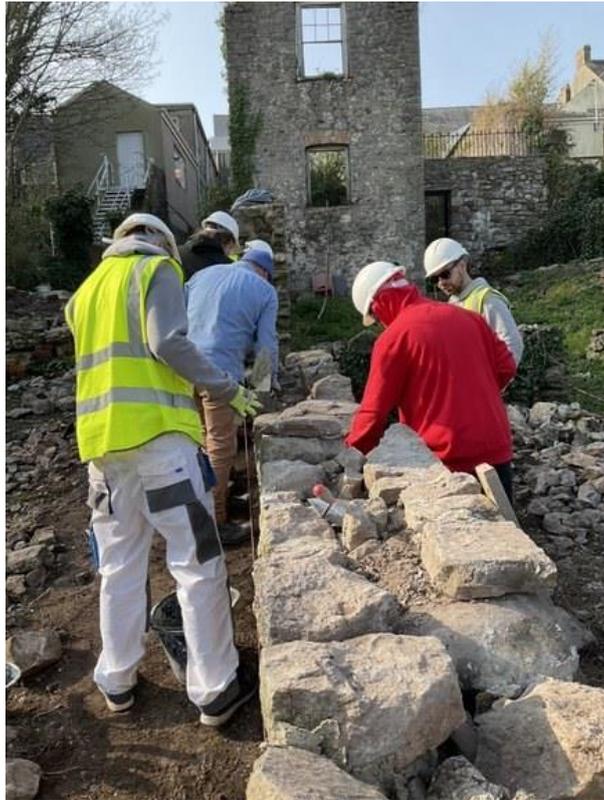
*6 - Filling the wall with smaller stones*

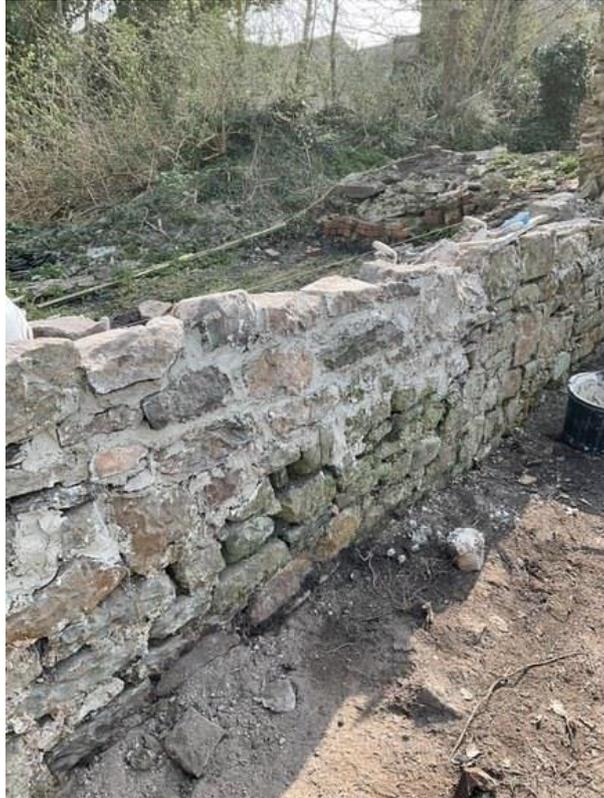
*8 - The first course of new stones in place*

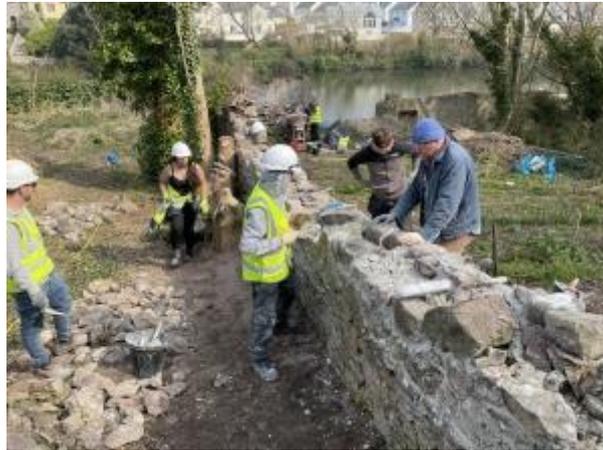
*9 - Stones being laid in place to check they met with the existing course below*

Existing courses of stones which were left from the historical build were repaired and completed, with further courses laid out and then set in mortar once Oliver and the learners were happy with their position.

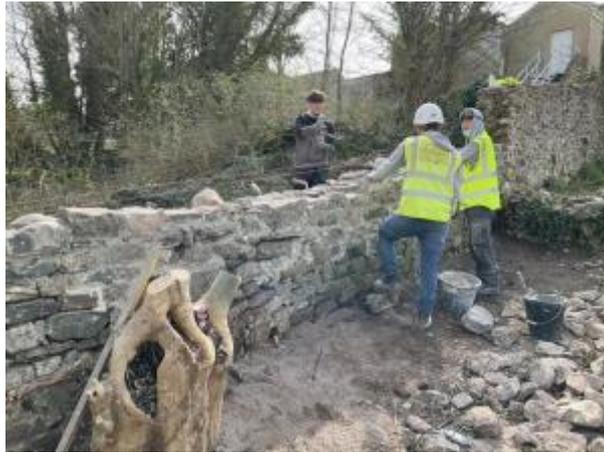
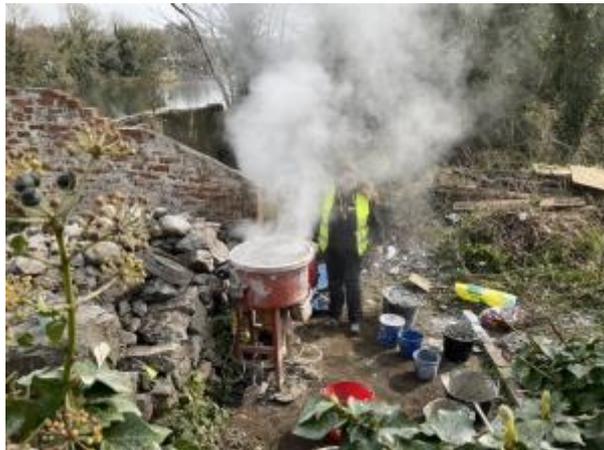
*10 - Tara overseeing the hot lime mortar mix, which was used to ensure the wall was rebuilt using historically accurate mortar*

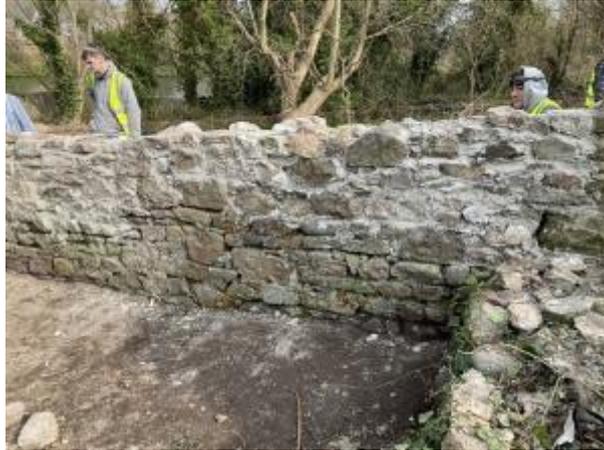
*11 - The new part of the wall, with the lighter mortar blending in well with the existing wall*

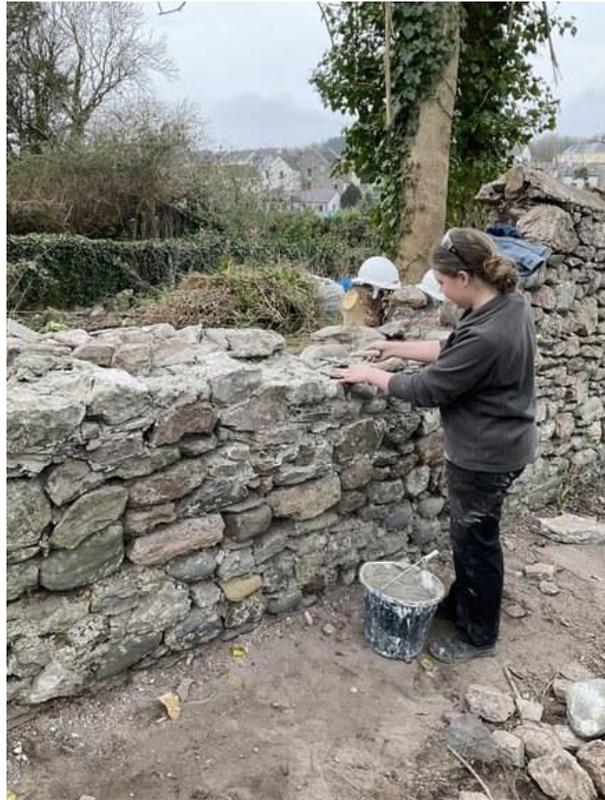
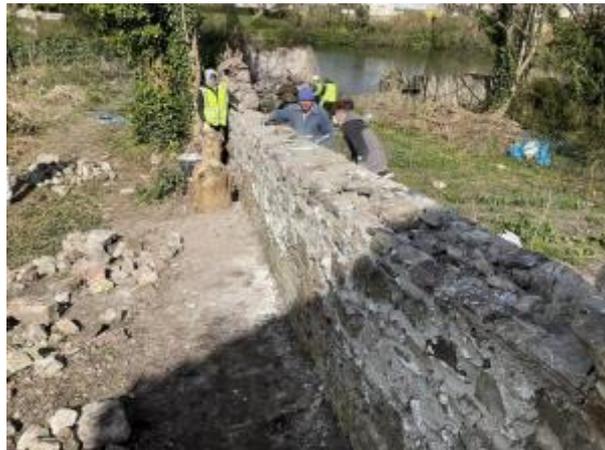
*12 - Phase 1 of the project is nearing completion and the wall is filled and levelled off*

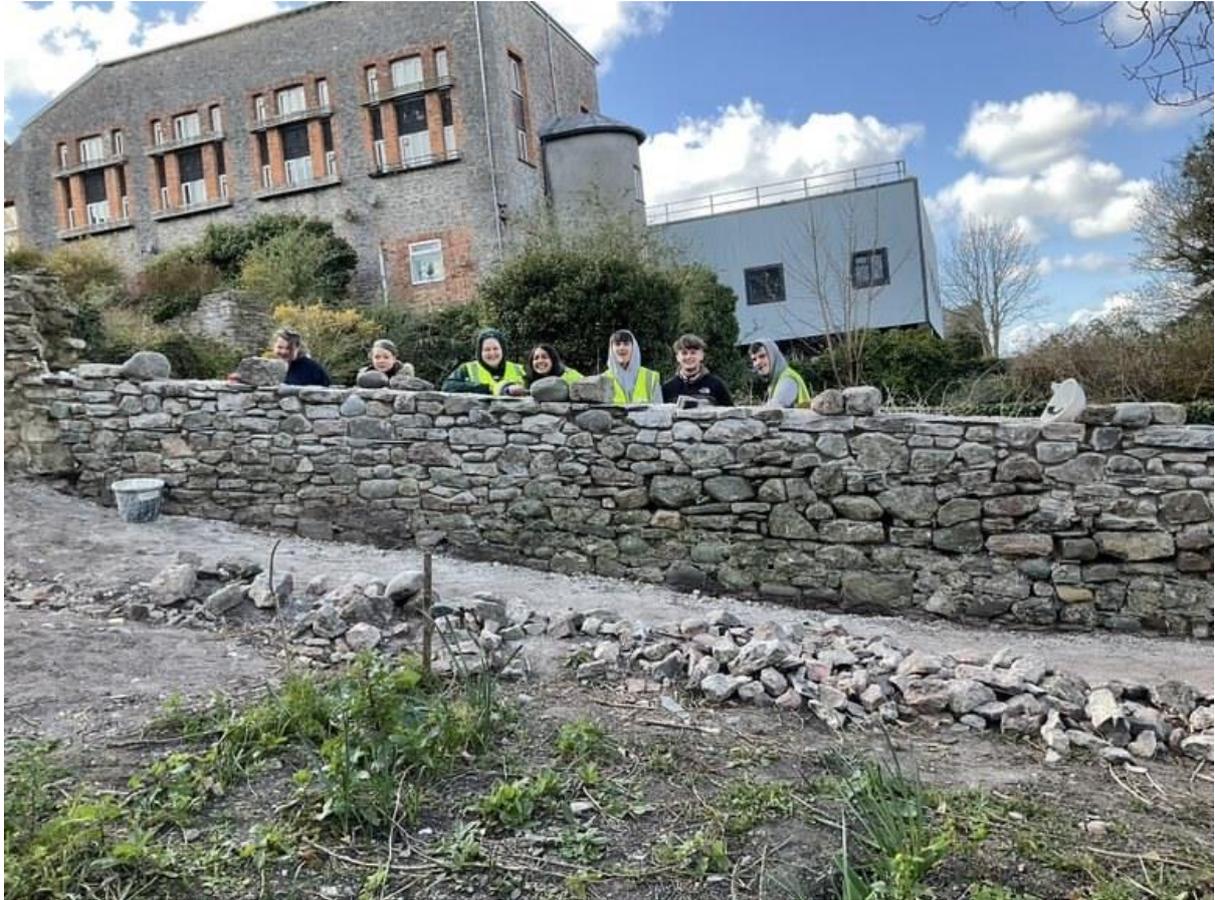
The project is completed for the first week, with the wall rebuilt with level courses and the mortar scraped away from the face of the

stones to give a clean finish. The new built wall fits in well with the existing wall and in places it is difficult to tell old from new
